ARB - CLASSIC PLUS CANOPY

XCLS18 - Mitsubishi Triton Dual Cab 2024+

XCLS19 - Nissan Navara Dual Cab 2026+

Central Locking Rear Door Canopy

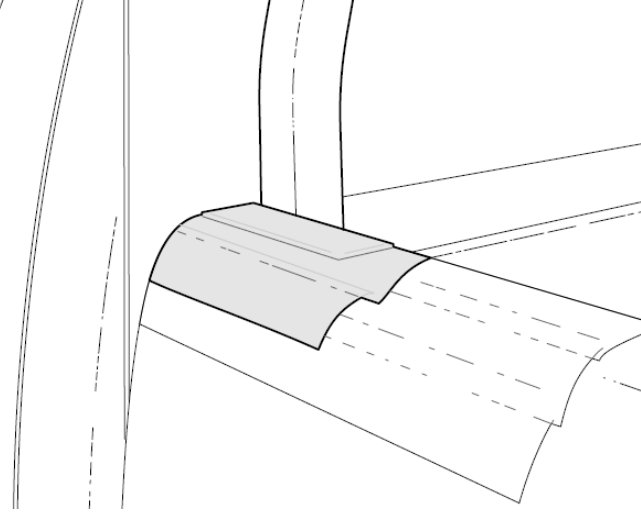
<p>1.2) Apply 200mm lengths of overlapping masking tape to the top and side of the tray, up to the cabin guard main support leg on both sides of the tub.</p> <p>1.3) Position the steel protective grinding plates (3199779) (2mm thick) next to the cabin guard main support leg on both sides of the tub.</p>

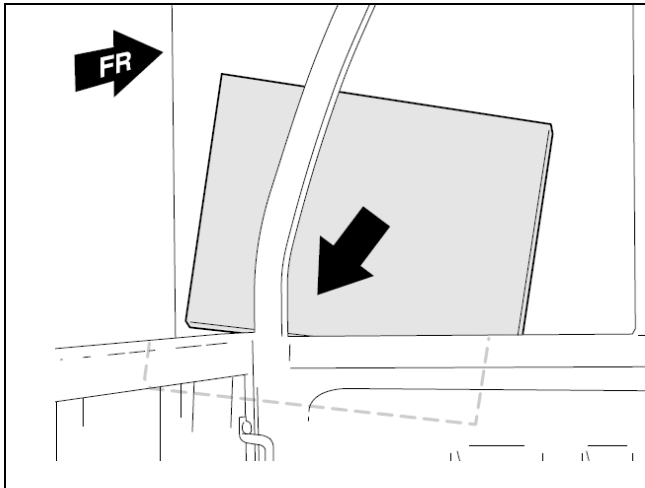
<p>1.4) Secure the protective steel grinding plate to the tray body by covering it completely with masking tape as shown.</p>

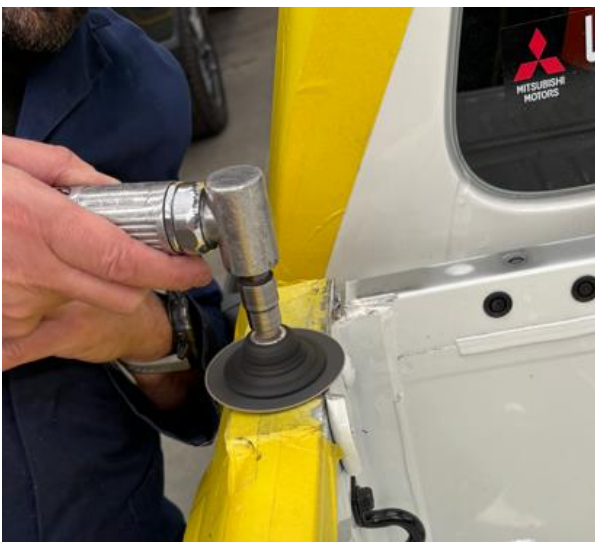
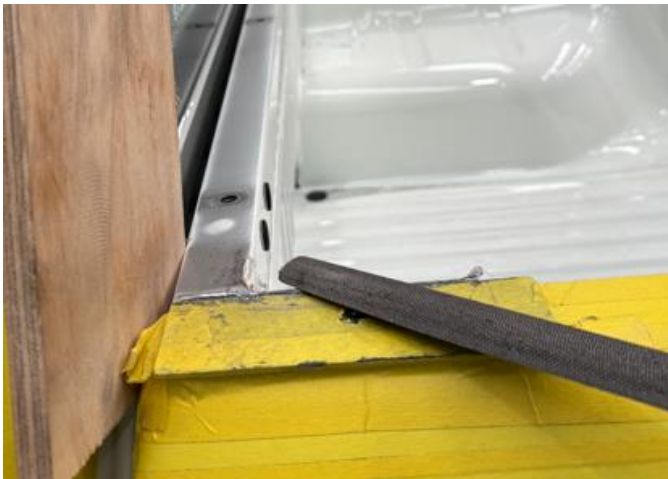
- 1.9) This will leave the lower gusset brackets from the cabin guard still attached to the side of the tub. These are to remain in place on the tub. Grind the remaining areas of the cabin guard flush with the top of the tub side and the with the front head board top face of the tub

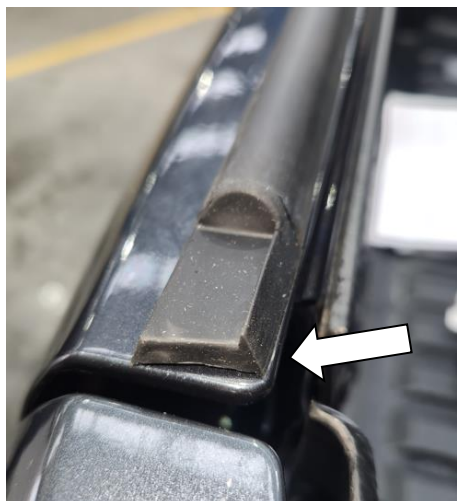
2.1) Test fit the rubber door sealing tub stop assembly (667AQ001) with the curved overall profile of it facing towards the rear of the vehicle, to the top of the tailgate, aligning the inner ends to the inner ends of the tailgate and apply masking tape along the outer edge of it and then remove the door sealing tub stop assembly.

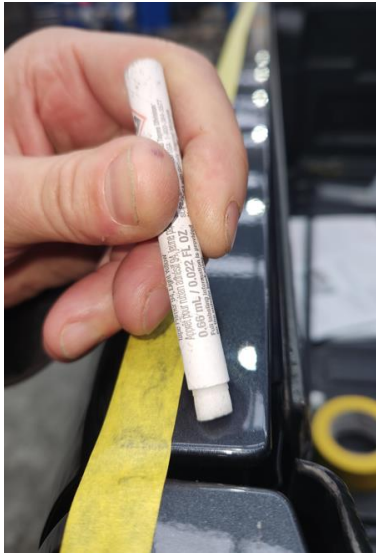
2.2) Apply primer (665044) by squeezing the primer stick until the tip is damp. At a 5mm offset to the tape edge, apply primer in a 15mm wide area across the tailgate where the rubber door sealing tub stop assembly is to be positioned and let it dry.

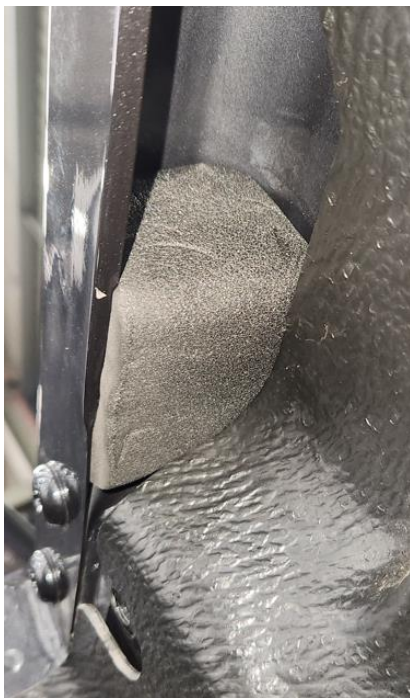
3.1) At the front corner of the tub remove the rubber grommets in the corners and discard them.

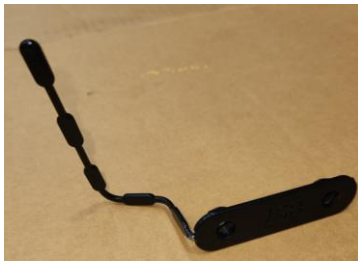
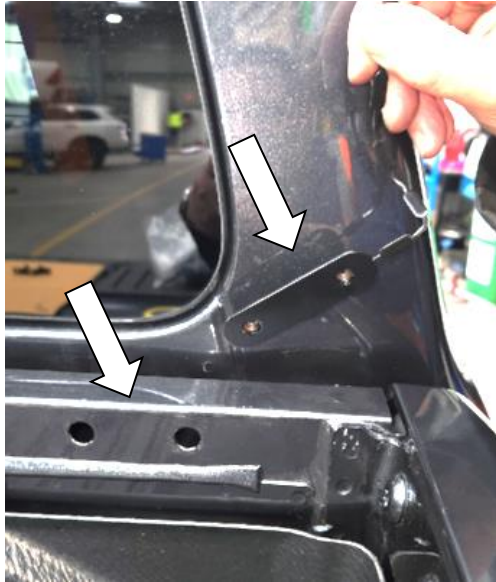
3.2) **!! IMPORTANT !!**
If fitting to a vehicle that has had the OE Roll top tonneau cover and sailplane removed, use the contents of the additional kit 6178553 and brackets 669AQ042R/L. Refer to the fitting instructions in this kit (37800359) for this step and the next step.

If NOT fitting to a vehicle that has had the OE roll top and sailplane removed, fit between the cabin and the tub place in nut plate (669AQ041) to align to the holes where the rubber grommets were removed. The end of the nut plate may be bent to a shape to provide access for fitment. Place masking tape on the back of the cabin before it is inserted to prevent scratching the cabin's paint work.

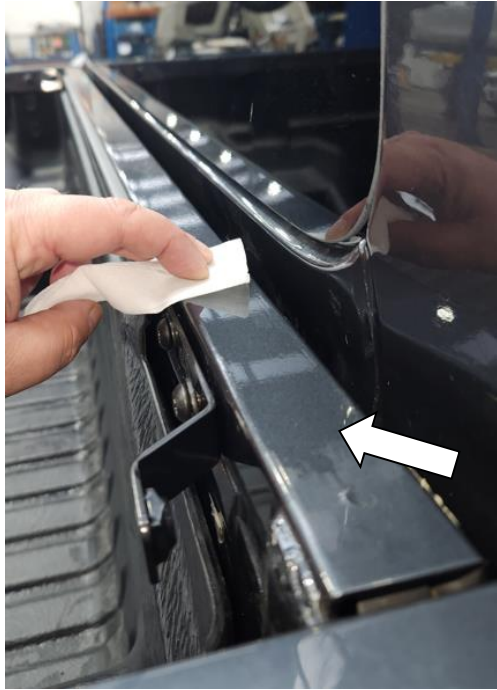
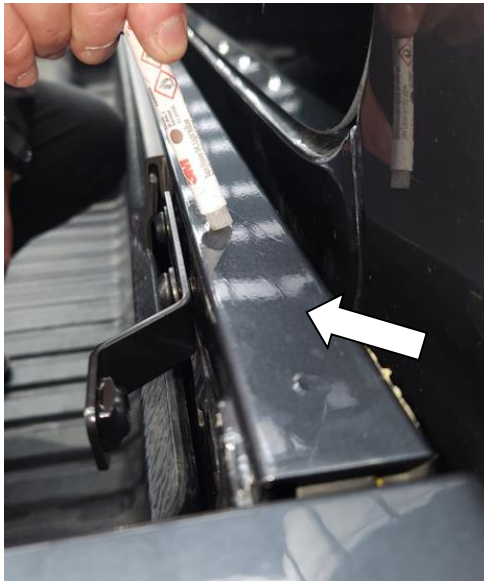
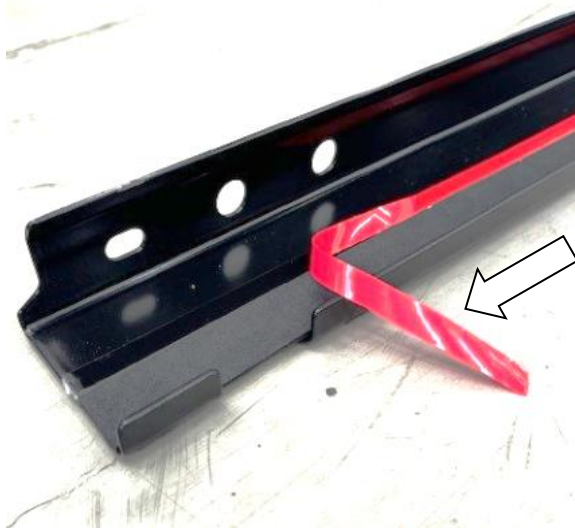
3.3) Loosely bolt up the header rail support bracket (669AQ040) using two M8 x 19 OD x 2mm thick flat washers (4584393) and two M8 x 25 Torx button head screws (6151625) through into the nut plate (669AQ041) on the other side of the tub. Tighten, but allow brackets to still be slightly loose in position. The picture shows the arrangement for the right-hand front corner of the tub.

Once assembled, brake off the bend tag from the nut plate by bending it several times until it breaks off.

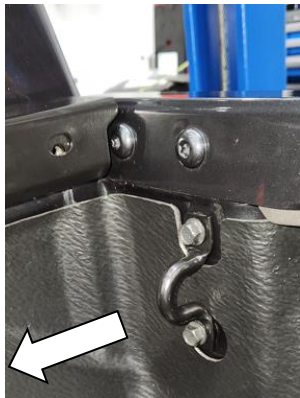
3.6) Remove the front tie down hooks in the front corners of the tub on both sides and give them to the customer with the bolts, or dispose of them.

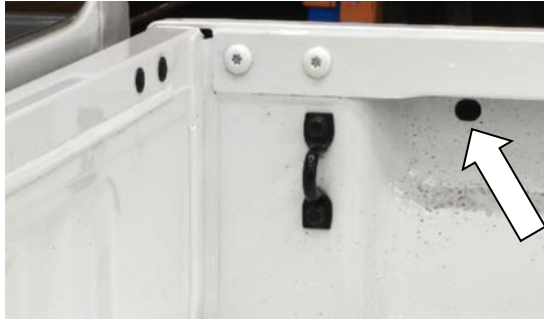
3.12) If no bedliner is fitted, apply black stickers (668PB006) on each side of the tub to the holes in the inner wall of the tub at forward and aft each side.

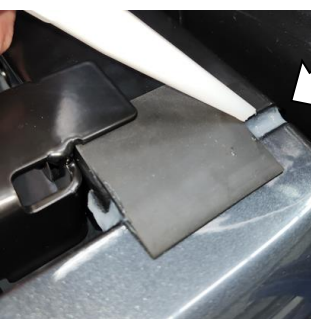
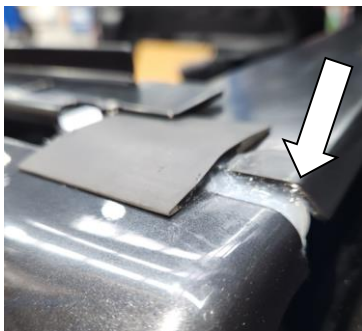
3.13) Apply (neutral cure non-acetic) silicon to the join between the front head rail to tub sides from underneath the bridge seal in the rear corner and at the front and the back side, to stop water leaks.

APPLY SILICON AS SHOWN OR FRONT CORNER WATER LEAKS COULD OCCUR

Carefully, clean off excess with a rag applied sparingly with silicon remover, or wax and grease remove and make the joins neatly.

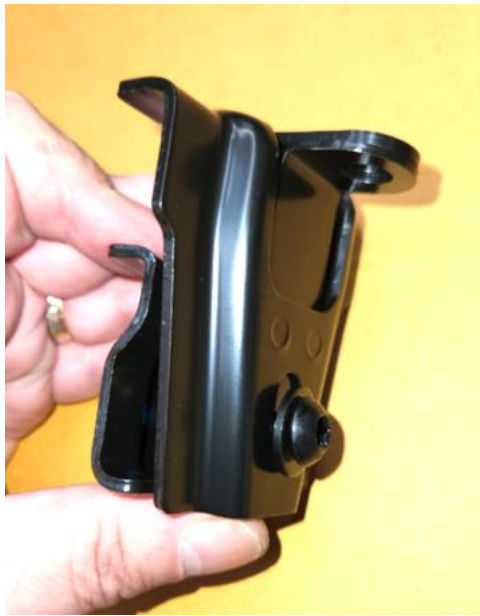
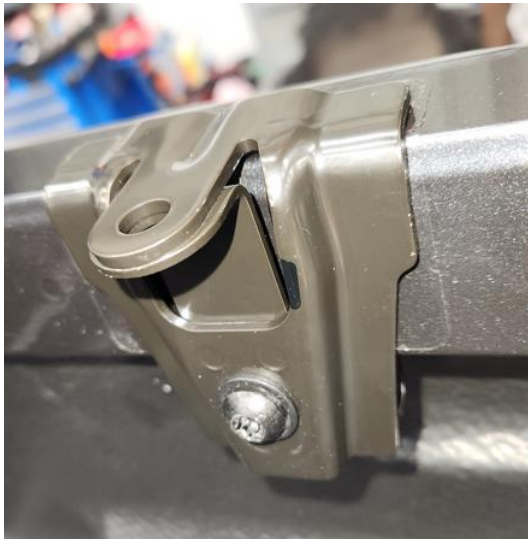
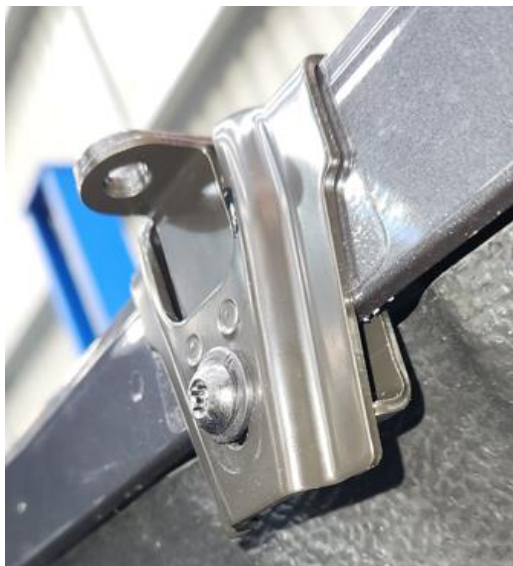
3.14) At the rear trailing edge of the front corner mount brackets on the top of the tub sides, measure back along the top of the tub and make **two marks at position at 415mm and at 1045mm on the side of the tub.** Apply four clear abrasion resistant pads (669PB004) (2 per side) at these positions **reward of the marks**, by aligning the 80mm long edge to the lower inner edge of the tub lip and the 64mm edge vertically, to the mark made on the tub and wrapping them up over onto the top of the tub rails.

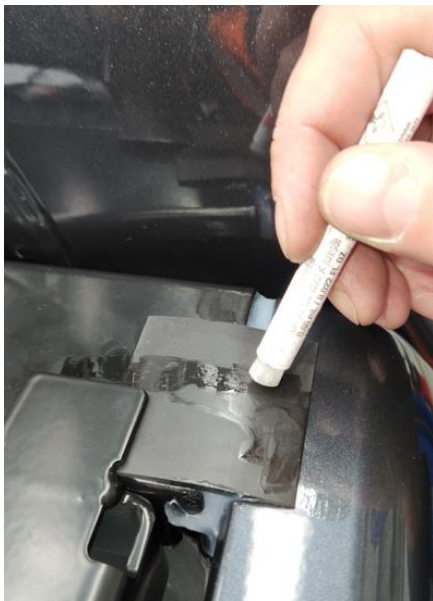
- 4.1) At the front corners of the tub, prime the area over the tub seal bridges (668PM005) using a primer stick (665044) (Break the vial at the dots by squeezing and wet out the felt tip to apply the primer).

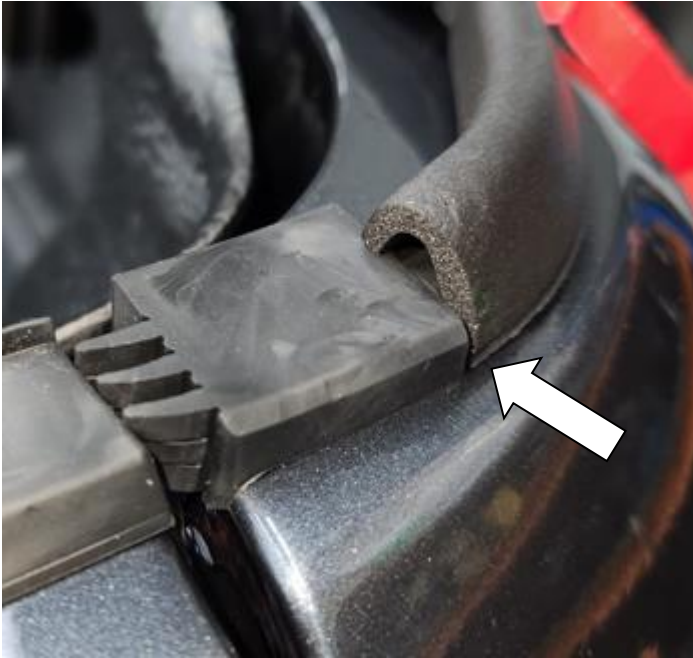
THIS SIDE TO THE
OUTSIDE OF THE
VEHICLE

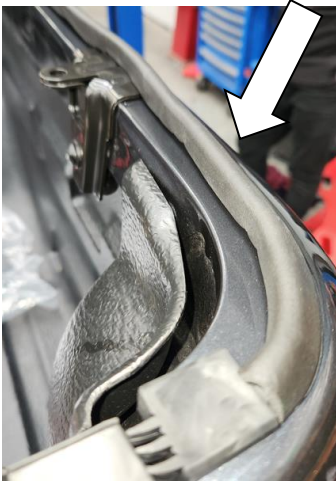
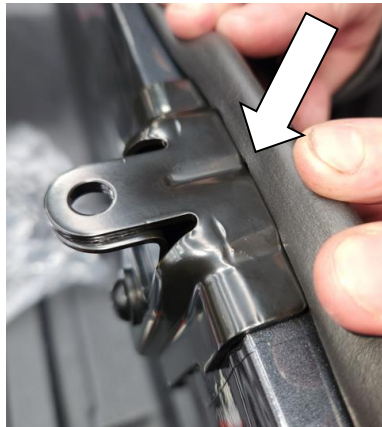
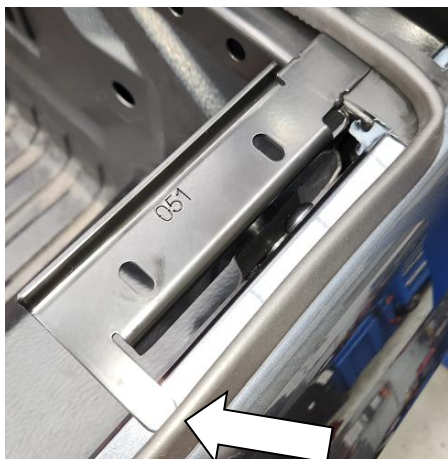
- 4.2) From the seal kit (6171422), clean the top of the vehicle's side tub rails down using alcohol wipes (6602018) out of the seal kit and allow to dry. Starting on the right-hand side at the rear tailgate end of the vehicle, slide the bed seal rubber extrusion (9009177) in the orientation shown, onto the spigot extending from the rubber side tub seal (667PE006R) ensuring the cut end is a neat tight fit between them. Remove the tape liner on the bed seal and curve it around the rear corner without puckering the seal and align the inner edge of the seal to the edge where the canopy mounting clamp assemblies (669AQ037) extends across the top face of the tub and continue to adhere the seal to the top of the tub so the inner edge contacts the rear finger on the front corner mount bracket.

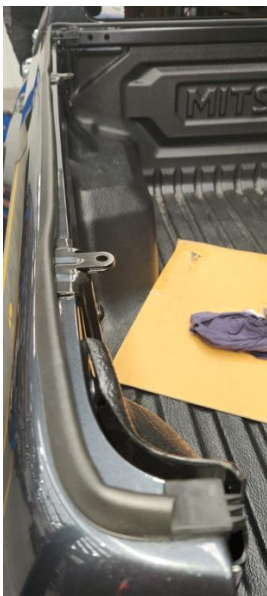
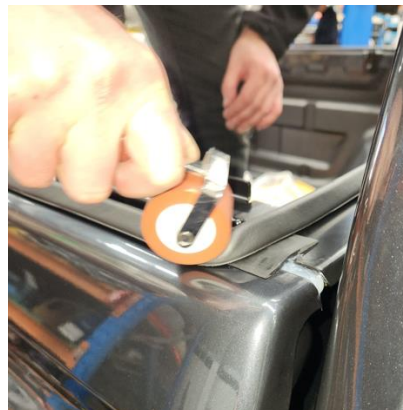
- 4.4) Apply the bed seal along the front header rail aligned at a 25mm offset between the inner edge of the seal and the inner edge of the header rail bracket.

Apply the seal with firm pressure to the front head rail using a printing roller.

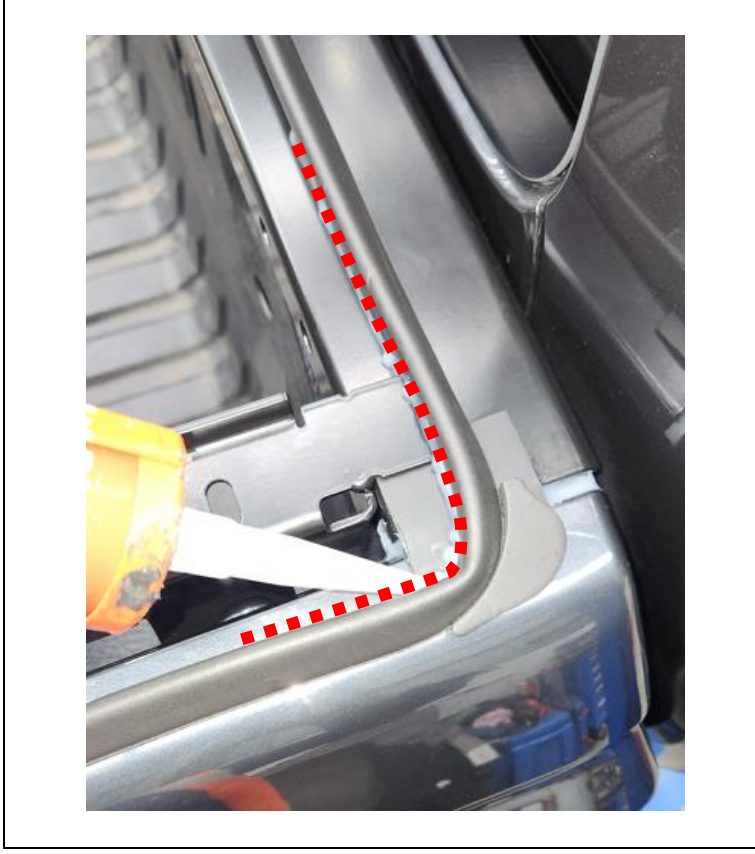
4.6) Split the pair of front corner foam seals (665082) and remove the backing paper and apply them to the front corners of the tub with the adhesive face down, so the outside edge of the foam pads are in line with the outside edge of the bulb seal (9009177) on each of the front corners of the tub.

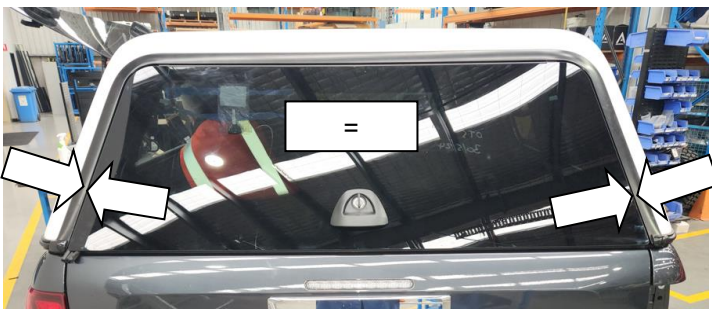
- 5.1) Centre the canopy across the tailgate by aligning the end caps on the door frame to the lower edges of the vehicle's tub adjacent to the tailgate. Ensure the gap between the door glass and the door frame is even, and between 3.5 and 7mm.

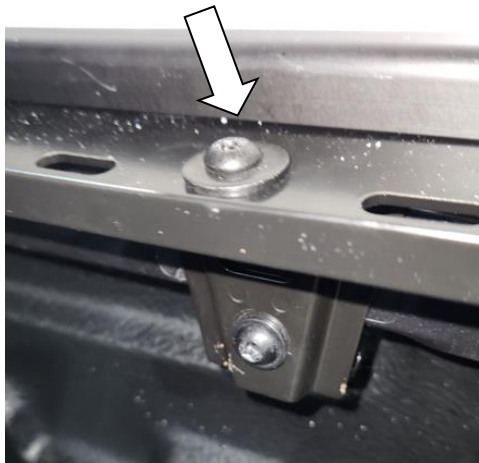
- 5.3) With the canopy centred and door gaps even to the glass, locate the sideways slotted hole in the rear corners of the base inside the canopy. Place an M8 x 25 Torx button head screw (6151625) with M8x25.4x3mm thick flat washer (4581303) in through the slot in the canopy's base rail and the canopy clamping bracket on the tub. On the underside assemble an M8 x 19 OD x 2mm thick flat washers (4584393) and a M8 nyloc nut (6151212)

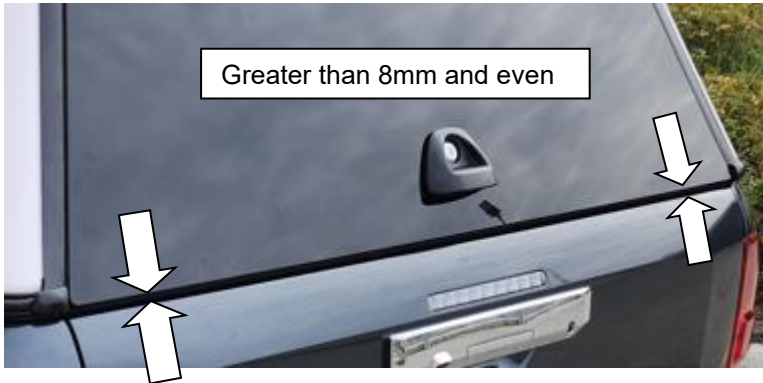
5.5) **!!IMPORTANT!! Ensure the gap between the lower door glass edges to the top of the tailgate is greater than 8mm (nominally it should be 10mm) and even left to right. If it is not, the canopy will need to be packed up with washers at the bolting points between the base rail and the rear most mounting clamps to the tub until minimum of 8mm is achieved and without loss of sealing of the canopy to the bed seal down the sided of the tub.**

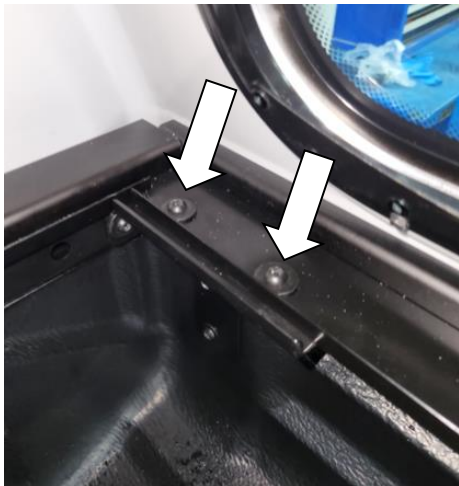
5.6) At the front interior corners of the canopy locate the forward/aft slotted holes in the base rail. Place two M8 x 25 Torx button head screws (6151625) with M8 x 25.4 x 3mm thick flat washers (4581303) in through the slot in the canopy's base rail and the front tub corner mounting bracket. On the underside assemble an M8 x 19 OD x 2mm thick flat washers (4584393) and a M8 nyloc nut (6151212)

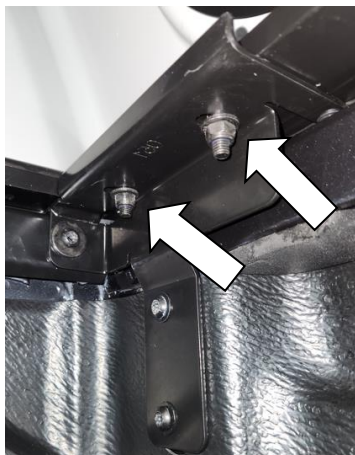
Tighten the M8 bolts between the canopy to the front tub corner mounting brackets to 20Nm.

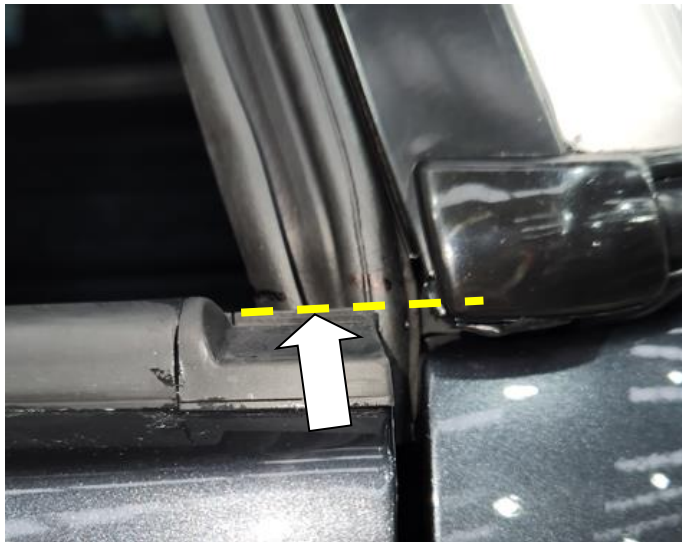
- 5.7) At the mid-point interior of the canopy locate the cross-wise slotted hole in the base rail. Place an M8 x 25 Torx button head screw (6151625) with M8x25.4x3mm thick flat washer (4581303) in through the slot and the canopy clamping bracket. On the underside assemble an M8 x 19 OD x 2mm thick flat washer (4584393) and a M8 nyloc nut (6151212).

Tighten the M8 bolts between the canopy to the tub mounting clamping brackets to 20Nm.

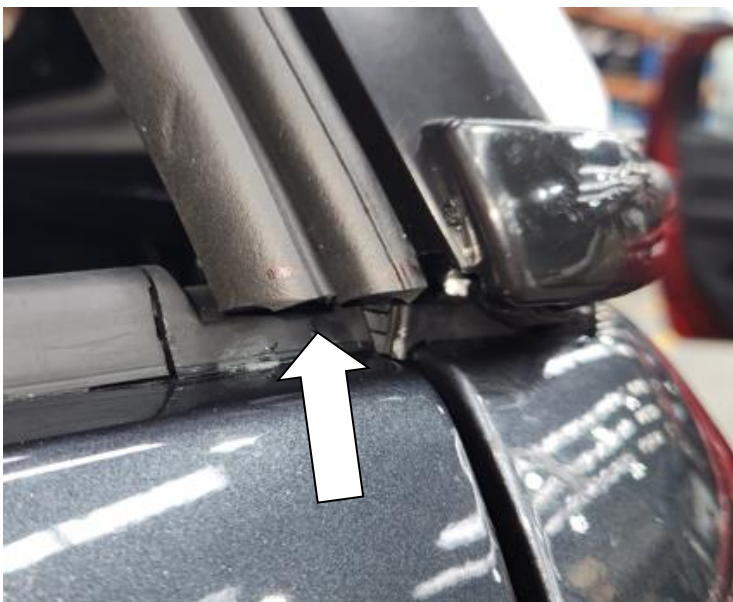
- 5.8) Close the vehicle's tailgate up to the edge gutter seals on the door frame. Mark a line across the seals where the ends of the tailgate door sealing tub stop rests against the door seals. **Measure 5mm down from this and cut the door frame seals horizontally, very neatly, with sharp scissors. Once cut, the ends of the door frame seals should just touch the recessed face of the top of the door sealing tub stop assembly (667AQ001) at each end of the tailgate.** Tune the cut ends of the door frame seals so the door seals just miss the top of the tailgate when it is opened so these do not foul and crush on the inside of the tailgate when it is closed.

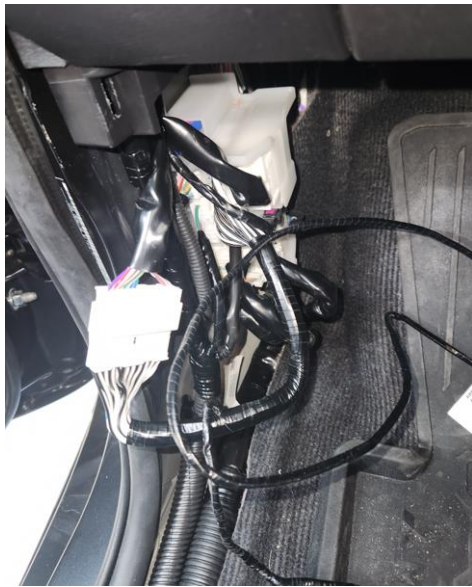
6.4) Locate the 40 pin large flat connector on the vehicle in the **uppermost MIDDLE** kick panel area, disconnect it and patch in the connectors from the shorter harness (669PJ025) and connect this between the 2 connectors on the vehicle. **Note if the canopy wiring does not operate correctly please check you have plugged into the correct location.**

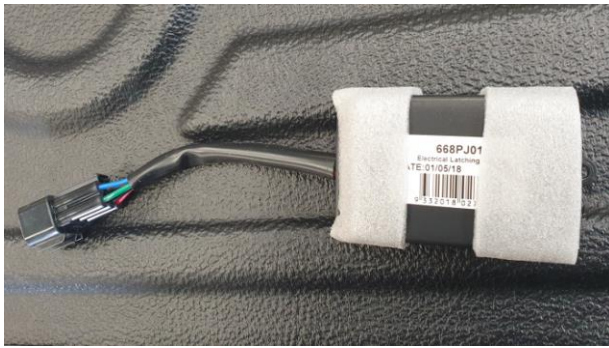
6.5) Use (668PB015) anti-rattle foam strips and apply in the two positions shown wrapped around (668PJ015) latch relay.

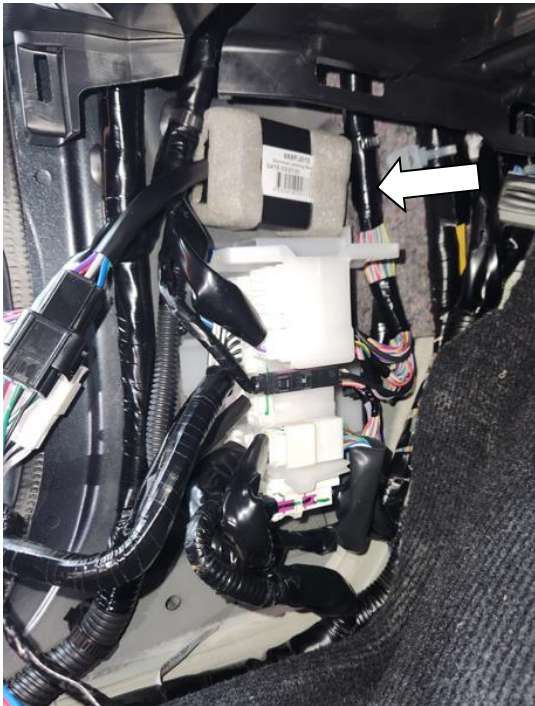
6.6) Connect the latch relay to the 6 pin connector on the canopy patch harness at the lower kick panel.

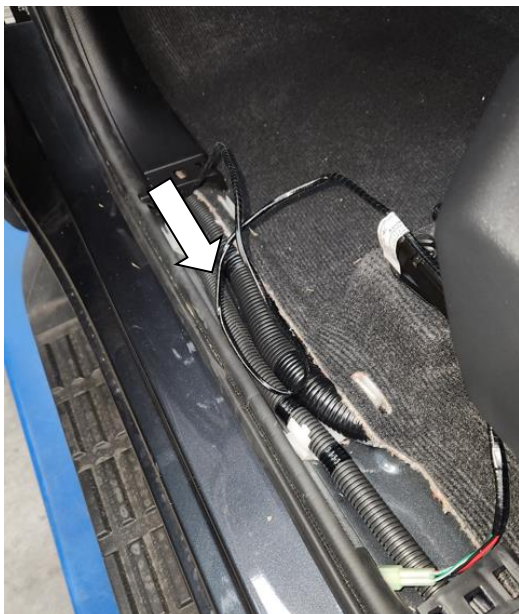
6.7) Position this on top of the vehicle's connector housing block and cable tie it through the loop on the relay box to the vehicle's wiring loom to secure it.

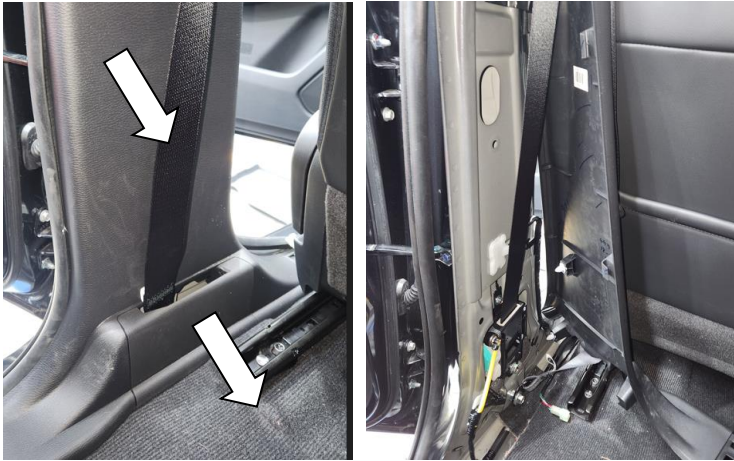
6.8) Reinstall the lower kick panel cover while running the loom rewards along the door sill edge near the edge of the floor carpet.

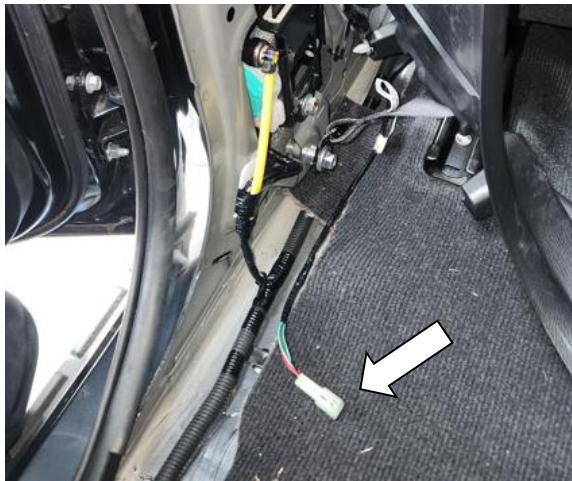
6.10) Run the loom to the mid position of the rear door foot well area, next to the floor carpet edge.

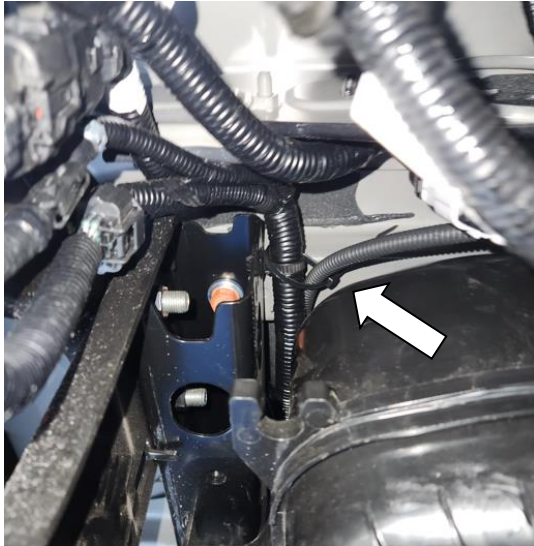
6.12) Under the vehicle, run the canopy patch harness with the 4 pin connector rearward along the left hand chassis rail following the vehicle's wiring path rearward/

Cable tie the loom to the vehicle's loom above the chassis rail every 200mm and avoid tying to brake lines, moving parts, sharp parts and away from hot exhaust systems.

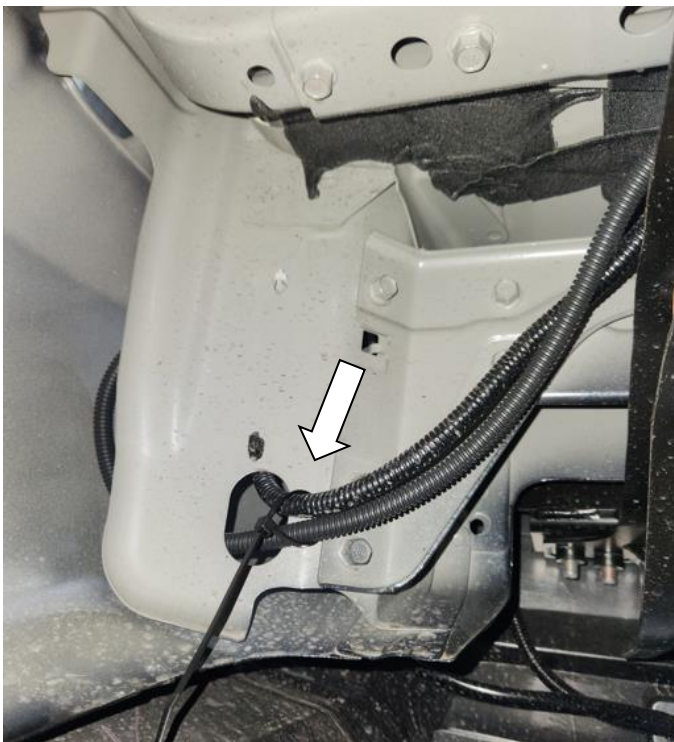
6.14) At the lower area under the right hand rear tail lamp, cable tie the canopy harness to the vehicle's harness and run it up into the tail lamp recess

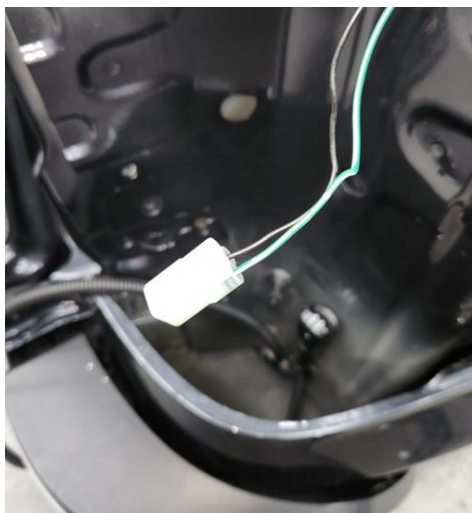
6.17) With the connection made between the canopy patch harness (666011) and the door loom at the connectors, cable tie this to the wiring at the mid position of the back of the tail lamp to ensure the connection is secured to the vehicle.

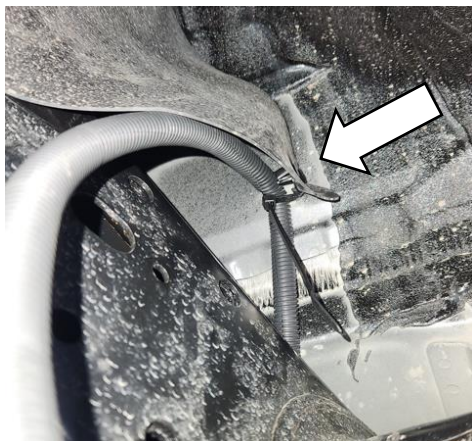
6.19) At the front left hand wheel well, cable tie the loom to the mounting bracket for the trim clip retainer. Then feed the loom up into the engine bay.

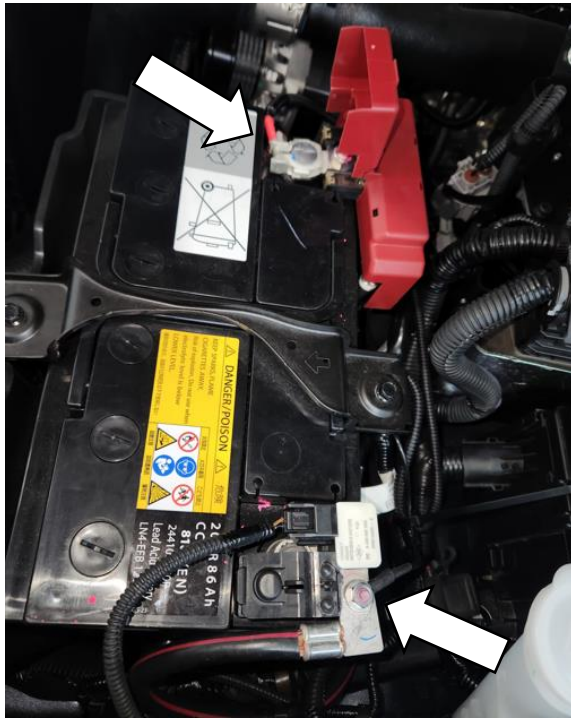
6.20) Open the bonnet and run the loom up against the firewall and around the back left-hand corner of the engine bay. Run the loom along under the area of the fuse box next to left hand fender towards the battery.

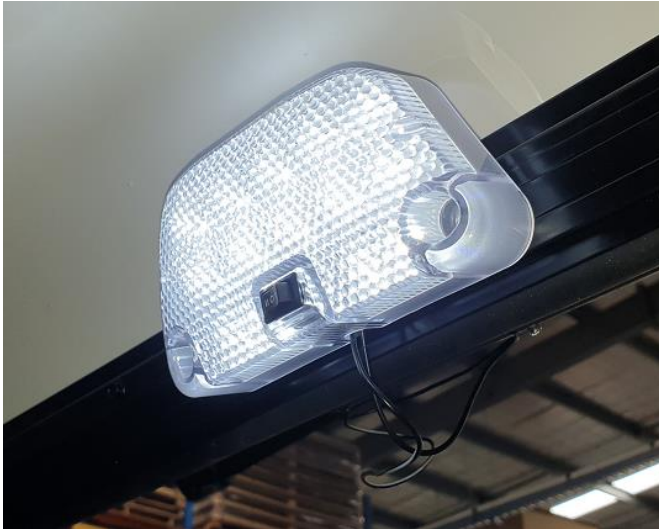
7.0) Check the interior light works when turned on and off.

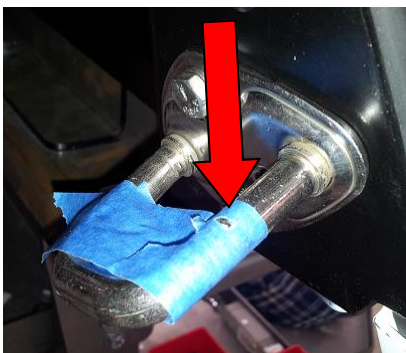
7.7) Place masking tape around the stainless-steel striker loop and slam the door shut 3 times.

- 7.8) **Check there is only wear on face that is rearwards from the vehicle.**
- 7.9) If there is wear on top or underneath on the striker loop, loosen the bolts on the striker loops and adjust the position of the loop up or down
- 7.10) Tighten and retest with tape again until the desired latch wear point is obtained. Once satisfied, tighten the striker loop bolts to **9Nm, using a torque wrench**

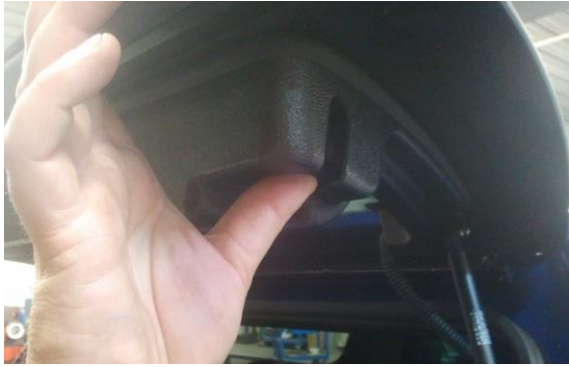
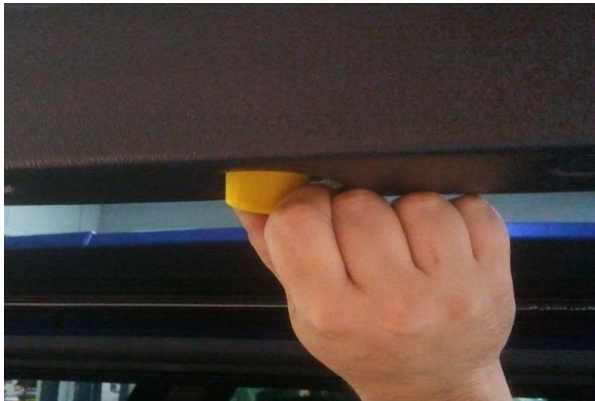
7.11) With the door open, engage both latches, then **SLOWLY** twist the yellow release handle and listen to hear if both latches open at **EXACTLY** the same time.

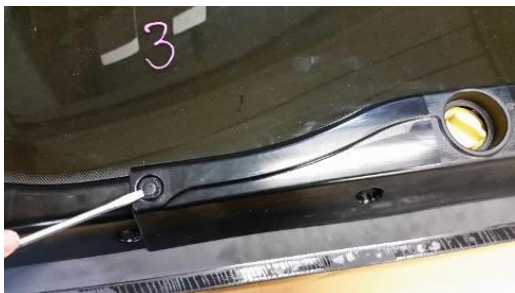
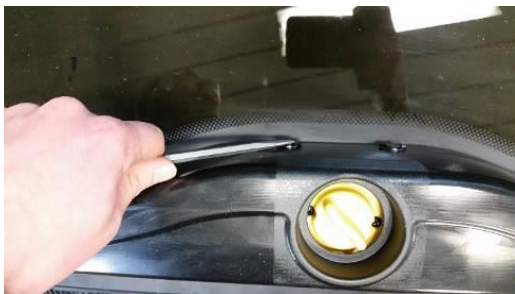
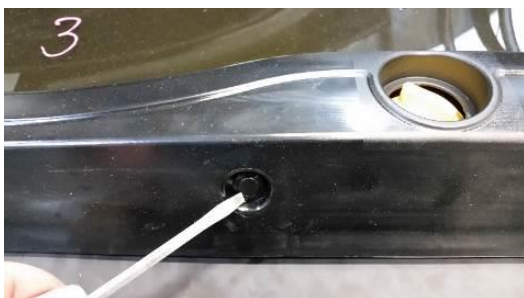
7.12) If the latches don't release at the same time, remove the 6 screws holding the centre cover, remove the centre cover to get access to the latch rods.

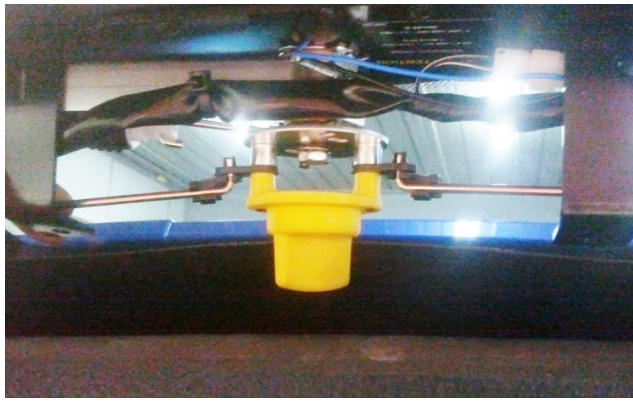
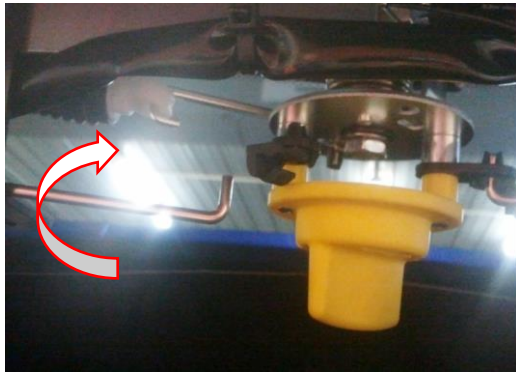
- 7.13) On the side which released last, remove the rod clip and pull the pull rod out. Rotate 1 turn to shorten it.
- 7.14) Reinstall the rods into the clips, **CLIP THE ROD END SHUT.**
- 7.15) Retest the latches by operating the interior handle to check they work simultaneously.
- 7.16) When satisfied, replace the covers, **CHECK ALL 6 SCRIVETS ARE REINSTALLED.**

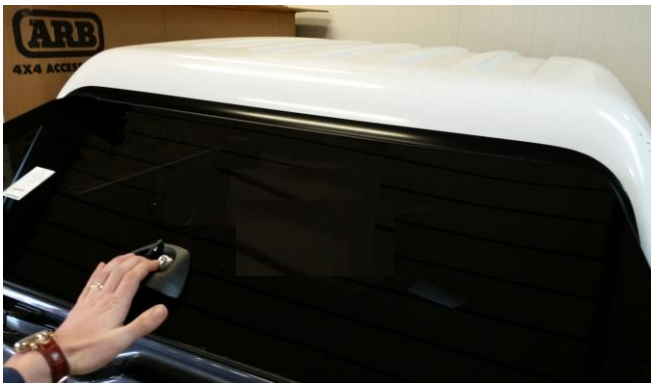
- 7.17) **Shut the door as gently as possible for a latch to engage.** Check that both latches engage at **EXACTLY** the same time.

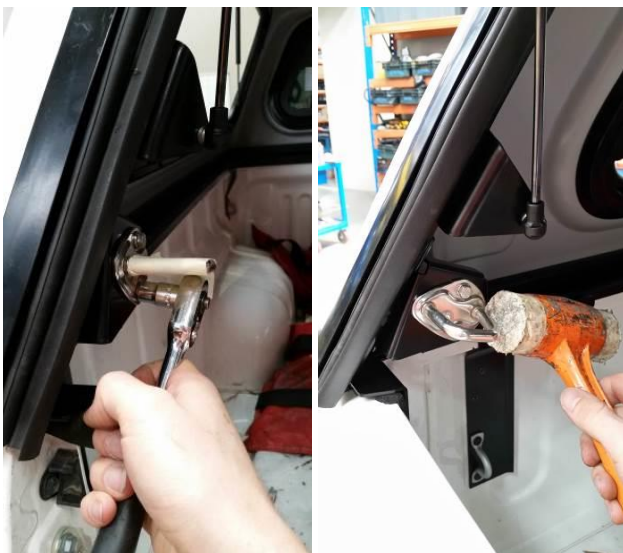
- 7.18) If the latches don't engage at exactly the same time, loosen the 2 stainless steel M6 screws and tap the latch striker forward 1-2mm.
- 7.19) Retighten the M6 bolts to **9Nm using a torque wrench**, retest the door during closing to check.
